Aviation Safety

Ultralight and Balloon

Issue 2/2000

Analysis of Recent Incidents

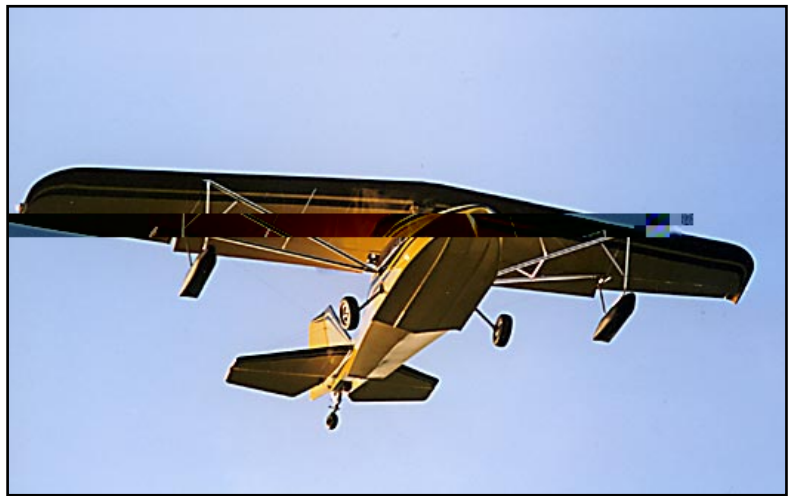
The SeaRey shown above is similar to the aircraft involved in the accidents.

The second SeaRey accident resulted from a maintenance oversight while the owner/operator was inserting a strut bolt to hold the rear wing strut in place. The AN-17a bolt (part 11 on the diagram on p. 2) was removed to install another component and was immediately replaced. However, unnoticed by the installer, it was inserted in such a manner that it missed the hole in the main strut attachment fork (part 5 in the diagram on p. 2). As a result, the strut pulled out of the fitting and the port wing began folding immediately after takeoff as the weight of the aircraft transferred to the wings, resulting in an uncontrolled encounter with the terrain beside the runway. This type of oversight has occurred on various types of aircraft in the past (see the front page article, "Missing Bolt Fatal," in issue 2/95 and issue 1/95 "Incorrect Assembly," another article dealing with the same type of incident).

The bolt identified as part 11 was inserted inadvertently missing the hole in part 5, which was vital if the rear wing strut were to be held securely. Instead, the bolt went beside part 5, allowing part 5 to pull out of the strut when the weight of the aircraft becoming airborne was transferred from the wheels to the wings, thus allowing the left wing to fold.

How can this type of oversight be eliminated? If working alone, as is often the case where small aircraft are concerned, the whole job must be reinspected by the owner or preferably another knowledgeable person prior to flight. In other words, completely double-check your own work against existing manuals and procedures to ensure correctness before attempting flight after maintenance. There are no regulations governing ultralight or advanced ultralight maintenance, so the aircraft owner must get it right. Double-checking maintenance is standard practice in the aviation industry where supervisors regularly inspect the work of subordinates. With the introduction of "owner maintenance" in the general aviation industry, it will become more important for owners to realize that it is a safety benefit to have work reinspected or double-checked. Unfortunately most ultralight owners and amateur-builders work alone, a practice that can set up a situation for a maintenance accident. —Ed.

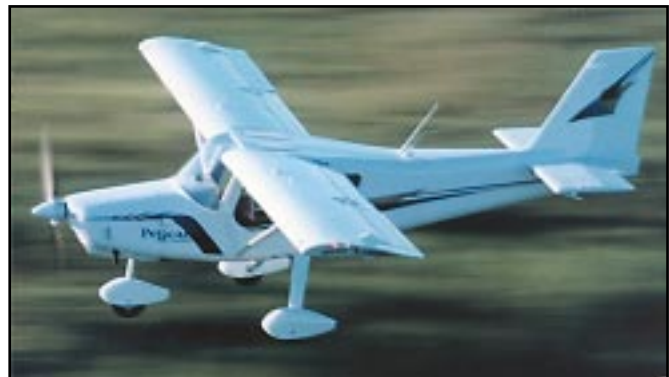
The pilot of an **Ultravia Pelican Club**, reported losing a door in flight. There was no further damage and the pilot landed OK.

Pelican Club similar to the aircraft involved in the Pelican incidents.

The pilot of another **Ultravia Pelican** was less fortunate. Observers on the ground noticed the aircraft strike a taxiway light and damage the propeller before departing for Iqaluit. Upon failure to arrive at his destination, he became the object of a full-scale search.

The aircraft was subsequently located where it had crashed on the side of a hill, 49 mi. south of the destination. The weather conditions as revealed by the hourly reports at Iqaluit were conducive to instrument flight rules (IFR) at the time of the flight. The ceiling was between 100 ft scattered and 200 ft broken, and it is believed that the pilot encountered IFR weather conditions during flight. The evidence gathered by the search and rescue team at the crash site seems to confirm that the aircraft crashed following a stall. It is assumed that the pilot, who was not qualified to fly in instrument conditions, lost control of the aircraft after becoming disoriented in cloud.

A third **Ultravia Pelican Club** aircraft was on a visual flight rules (VFR) flight plan when it apparently crashed and was spotted by a local resident about 500 yards from the shoreline upside down on a shoal. No further details of this incident are available, except the TSB noted that the same pilot was involved in previous accidents in 1991, 1993, 1994 and two accidents in 1997.

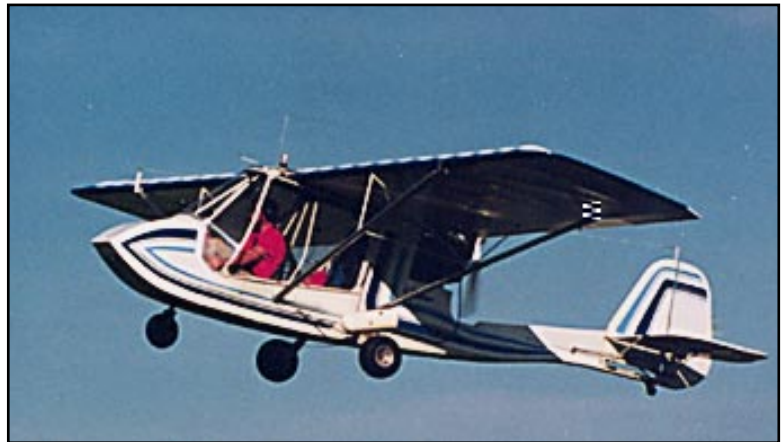
Quad City Challenger similar to the aircraft involved in the Challenger incidents below.

The pilot was practising circuits and landings at a northern Manitoba airport with a **Quad City Challenger IIA**. On the second circuit the nose gear came down hard onto the runway and bent, resulting in a loss of directional control. The aircraft came to rest beside the runway with damage to the nose and nose gear.

In a second incident at the same airport, a **Challenger** suffered a blown tire after landing and had to be removed from the runway. In a third incident at the same airport, a **Challenger** with one passenger was taxiing for takeoff when the nose wheel fell off at the intersection of the two runways.

The instructor and student in **Quad City Challenger II** were practising takeoffs, circuits and landings at a private grass strip. During a landing, the student lost directional control of the aircraft and it veered off the right side of the strip, hitting trees located approximately 20 ft away. The aircraft received substantial damage; however, there were no injuries. Weather was not a factor as winds were light.

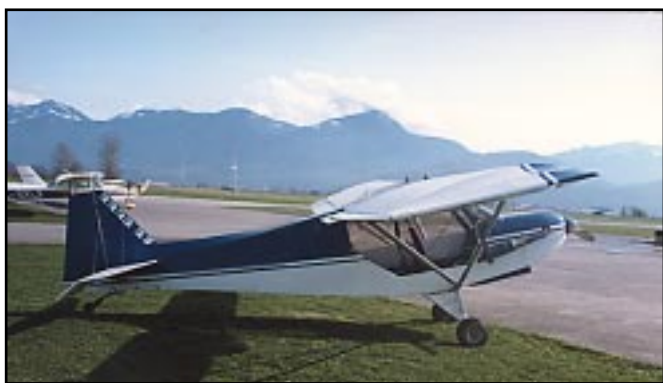
The pilot of a Rotax-equipped **Rans Coyote** was attempting a crosswind landing at his private farm airstrip in Alberta and was unable to get aligned with the strip. He attempted a go-around, at which time the engine quit. The aircraft touched down in a rapeseed crop and was substantially damaged. The pilot was not injured. No reason was given for the engine failure.

A Rans Coyote similar to the aircraft involved in the accident.

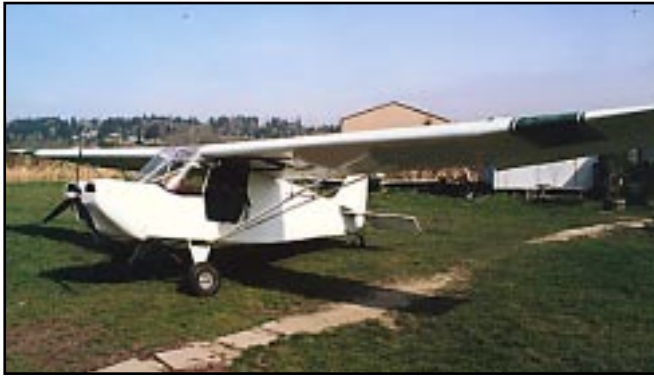
The instructor pilot of the **Yarrow Arrow** was instructing the student on stall recognition and forced landings. During stall recognition the **Rotax 503** (dual carburetors and single ignition) engine quit as power was increased to recover from slow flight. The instructor took control and made an unsuccessful attempt to restart the two-stroke engine. He set up on final approach, gliding at 45 mph toward a forced-landing area. At this point the ultralight experienced a severe and sudden drop in altitude, so the pilot revised his intended landing. He reported that he did not think he would reach his desired field and that he would hit a steep bank head-on; he resorted to a right turn and landed in a

wooded area. Both occupants suffered only minor injuries. The Yarrow Arrow was substantially damaged.

Photo of a Yarrow Arrow similar to the accident aircraft.

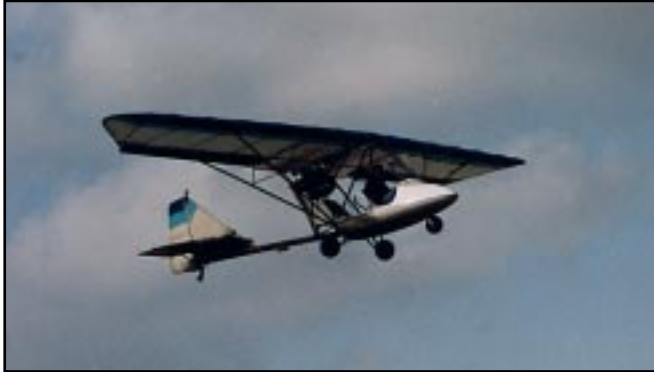
The pilot of a **Spectrum Beaver RX 550** was on a VFR flight out of the local airpark when he experienced a complete loss of engine power. The pilot carried out a forced landing into a small lake; however, the aircraft landed hard, and one of the amphibious floats detached. The aircraft sank in the shallow water and became partially submerged. The pilot was not injured and was able to swim to shore. The pilot suspects that a problem in the fuel system may have caused the engine, a **Rotax 582**, serial number 4015379, to stop running.

Photo of a Spectrum Beaver RX 550 similar to the accident aircraft.

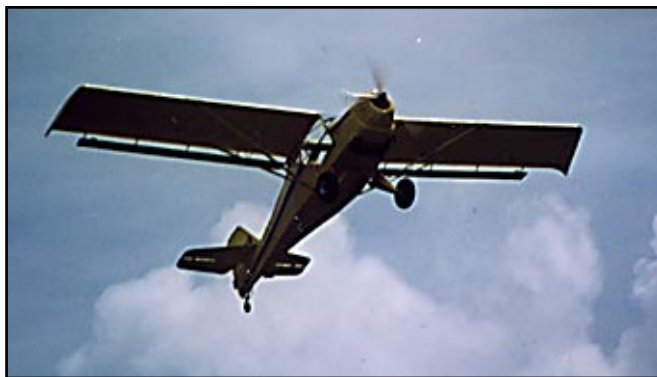
Photo of Kitfox similar to accident aircraft described below.

The pilot of a **Denny Kitfox II** was completing his roll-out after landing at a farm grass strip when

the aircraft lost the right wheel. The axle dug into the grass, and the aircraft overturned. There were no injuries, but the aircraft incurred a broken propeller, crushed cowl, collapsed lower fuselage and damaged tailfin.
